**IGLOO AND REVETMENT**

**NAVAL PROVING GROUND, ARCO, IDAHO**

**OCTOBER, 1946**

Army-Navy Explosives Safety Board 2029 Tempo 2 Building  
Washington, D. C.

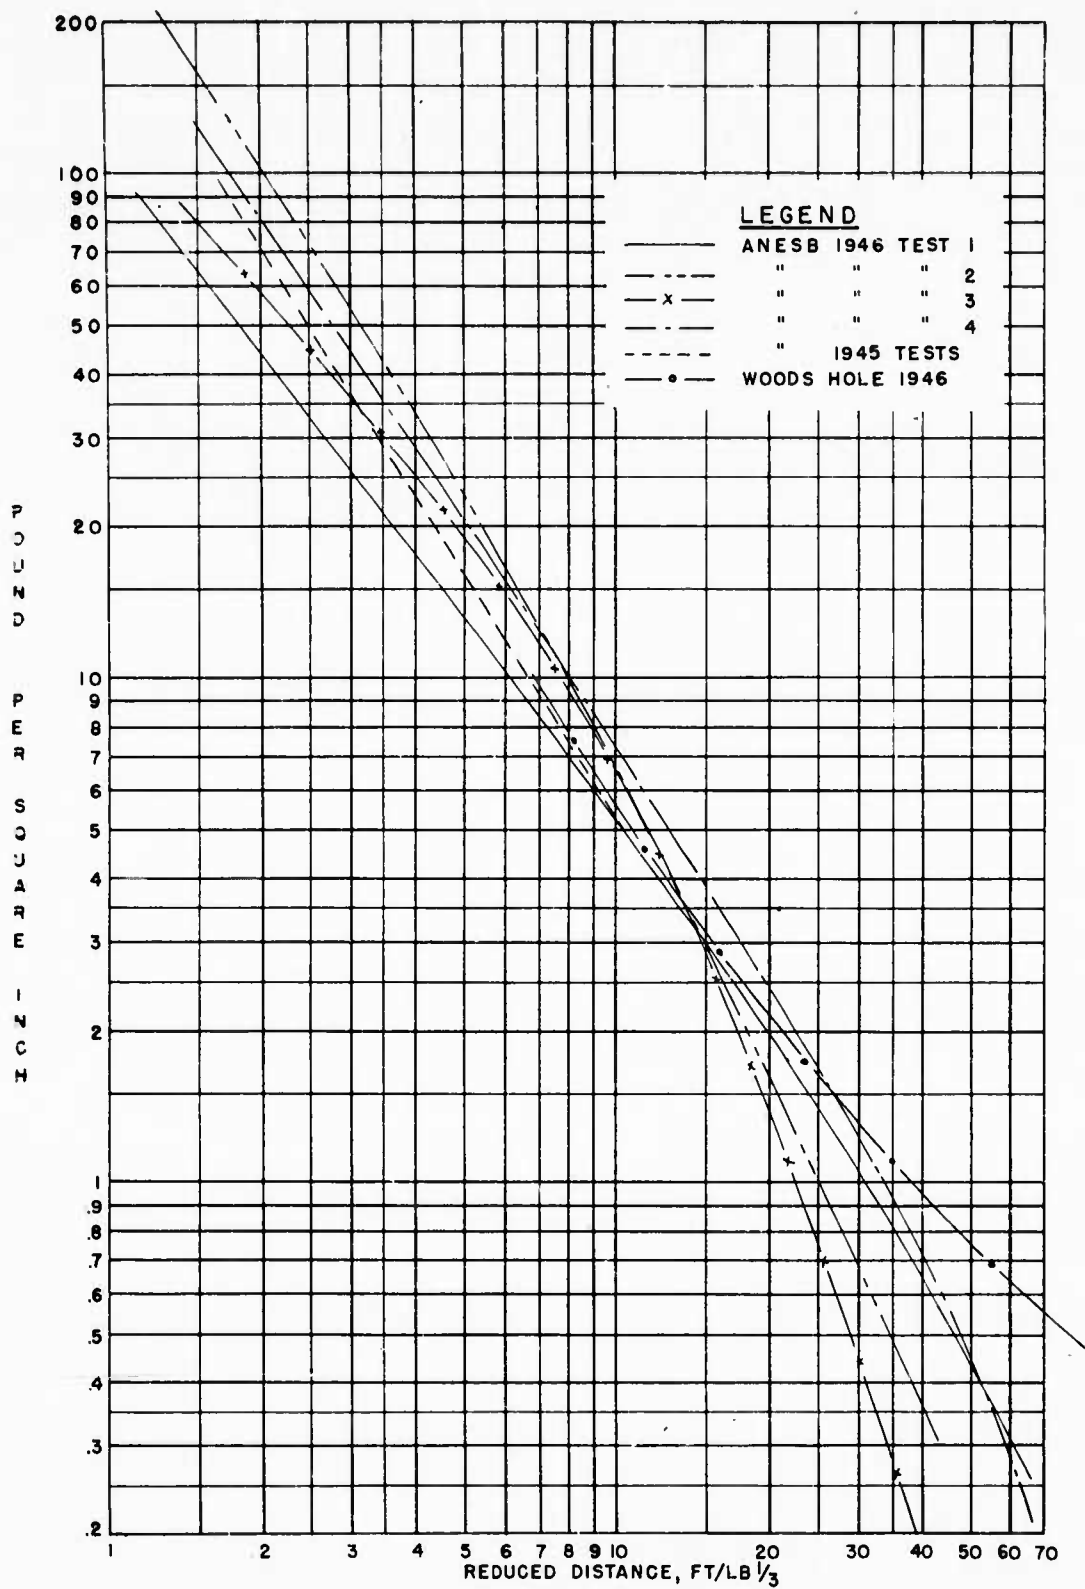
FIGURE 225A. Pressure-Reduced Distance Curves for Tests 1-4 incl. (Off Front)

(a) *General.*—To facilitate comparison and study, the peak pressure-distance curves obtained in the first four tests have been repeated in figure 225, but in this case pressure is plotted
